NATIONAL INTERAGENCY FIRE CENTER

March 21, 2005

NATIONAL FIRE EQUIPMENT SYSTEM CACHE MEMORANDUM NO. 05-2

Subject: Defective 3000 lb. Sling Swivels, NFES #0526, NSN #1670-01-029-8555

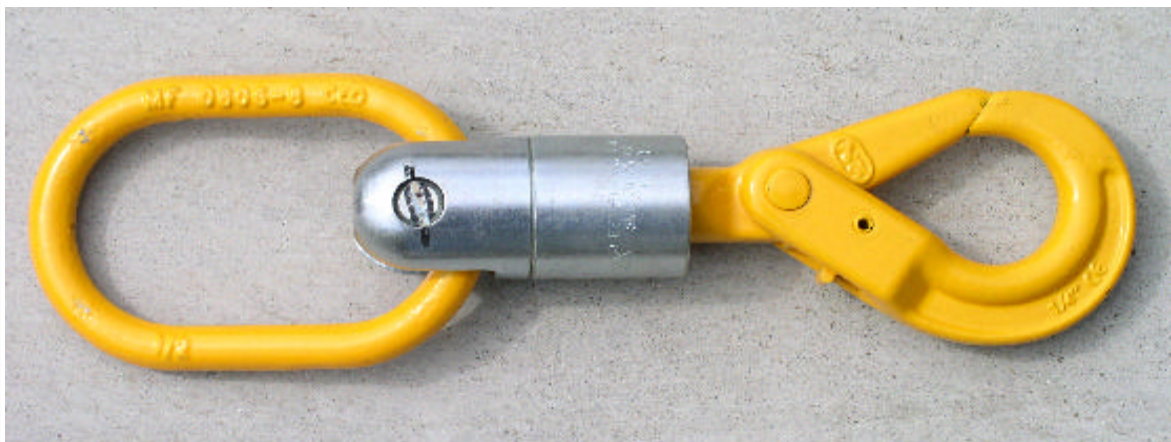
Background: During restocking of helicopter kits at the Ontario Fire Cache, several new 3000 lb. swivels were found to be frozen, meaning the hook would not turn. An investigation was started and the manufacturer was contacted. The problem is a latent defect caused by the assembly process. A method of inspection has been developed to identify the problem sling swivels and is described below.

Identifying the Product: Figure 1 shows the only known style of suspect swivels. The only manufacturer is Esmet, Inc. The date of manufacture for all discovered so far carry a date code of "9 03". The date stamp is located just below the manufacturer's name and the load rating on the silver colored swivel assembly. The manufacturer has stated that this style of sling swivel (figure 1) may have production dates as early as October, 2002 (marked "10 02").

Figure 1, Esmet, Inc. 3000 lb. Swivel

Reporting/Replacement Process: Defective sling swivels should be returned to GSA for replacement without charge. GSA will also assume all associated shipping costs. Owners of defective Esmet, Inc. manufactured sling swivels should contact Robert Regan, GSA National Customer Service Center, at 1-800-525-8027 (select "option 2") for specific disposition/shipping instructions. Returns on defective sling swivels will be accepted for free replacement only until September 1, 2005.

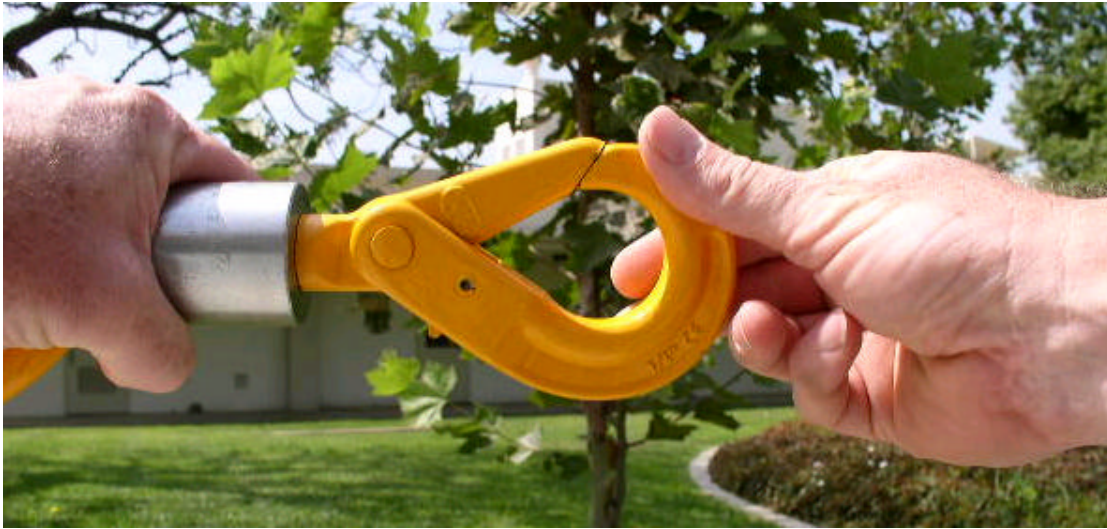
3000 Lb. Cargo Swivel Inspection: Grasp the swivel body in one hand. Using the thumb and forefingers of the other hand attempt to turn the hook (see figure 2). If the hook does not turn at all under finger pressure, the swivel has the problem and must be set aside for return to the vendor. If the hook turns under finger pressure but has locations of “binding” during the revolution, the swivel is acceptable for returning to stock/supply.

Figure 2, Finger Turning Test

Once you have determined the bearing is frozen do not attempt to break it free. Several swivels were found frozen and the inspector continued to work at twisting the hook which resulted in freeing of the bearing. This results in the inability to confirm the problem by the manufacturer when they receive it.

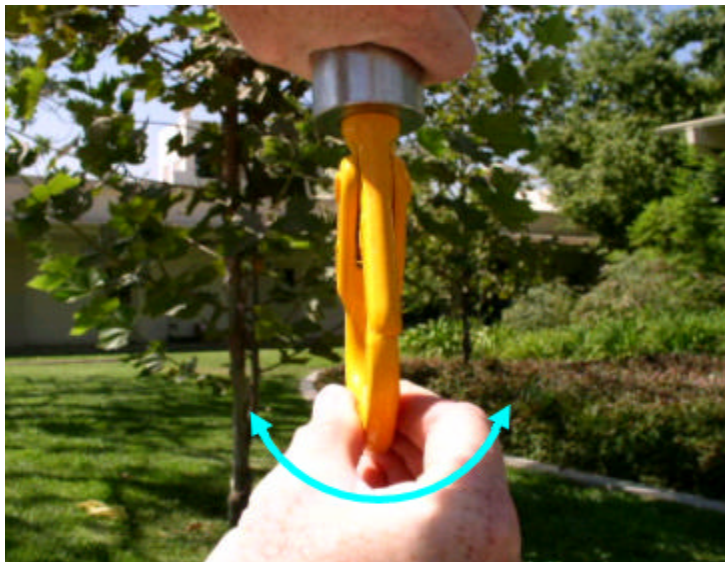
If lateral movement of the hook is found during inspection of the 3,000 lb. swivels, this does not affect serviceability and they may be returned to stock. Lateral movement is a side to side “swinging” movement of the hook under finger pressure, as shown in figure 3.

Figure 3, Lateral Movement
